# Manhole Inspection Summary

Manhole # S11EE\_008MH

**Location** Address: **REAR OF 3022 BELMONT AVE** Cross Street: **LONGWOOD ST**

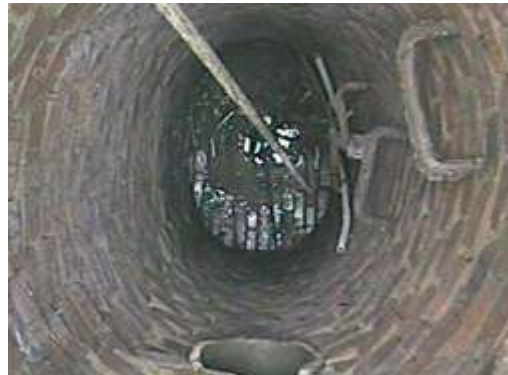
Top View

Comments **2 WAY TERMINAL-DOES NOT APPEAR TO BE ANY FLOW IN @ 6 O'CLOCK - GRADE OF PIPE APPEARS TO FLOW OUT OF MANHOLE**
